PROPERTY INSPECTION REPORT

Concerning: 3781 Fantastic Street, Great City, TX 75123

By: Minh Binh Nguyen, TREC# 10205

12/24/2009

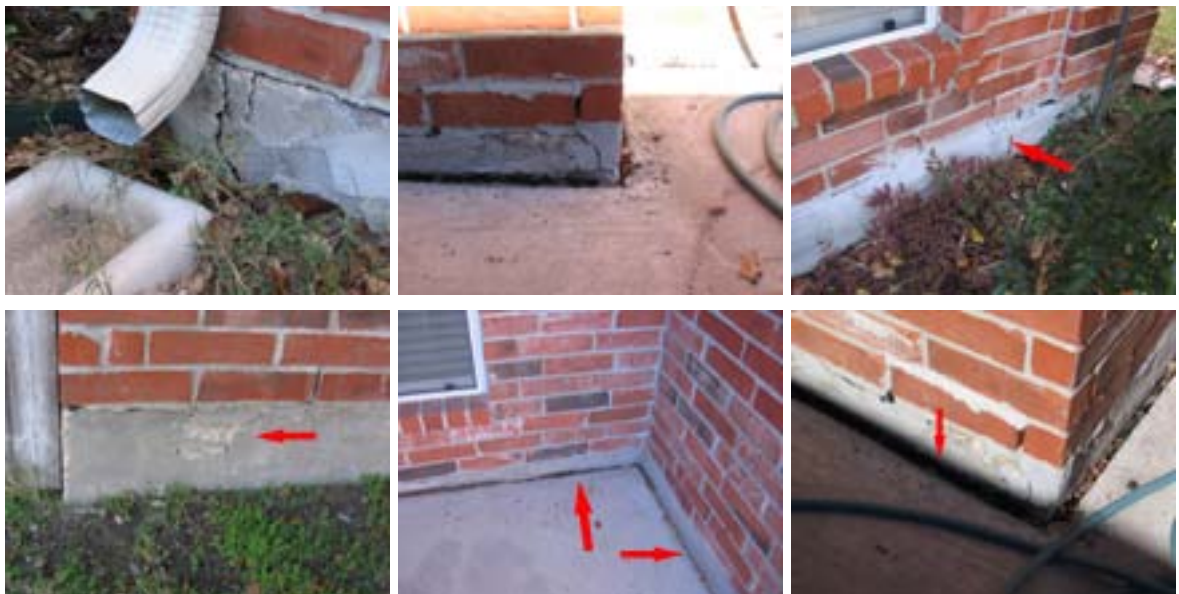
The foundation was parged in several areas, especially near the back yard patio. Several corner pops, corner cracks, and spallings found around the foundation. Most of the problems are more apparent near the corner where downspout were too close too the foundation. Perhaps excessive moisture was accumulated and deteriorated as the result of freeze thaw cycle. There are possibilities of the concealed water damage in these areas. Recommended to monitor and repair by a qualified contractor.

There is large separation from patio concrete and foundation that filled with debris. Recommended to repair by a qualified licensed contractor.

Plants are covering some section of the house. These plants could cause moisture to retain and insect infestation. Recommended to remove and trim away from the house.

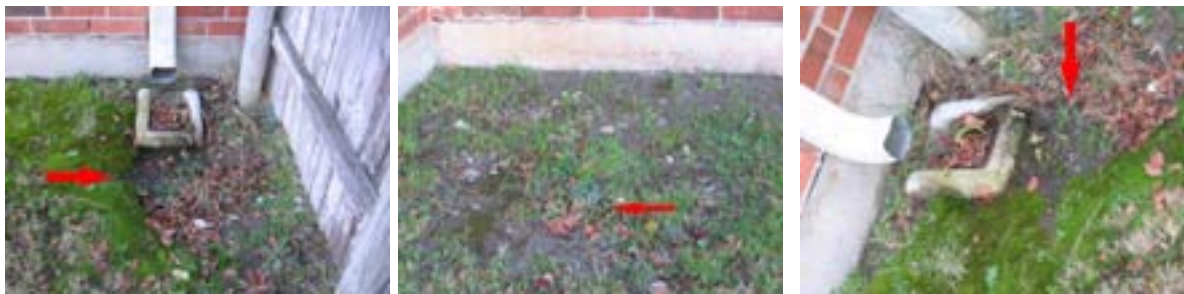
Gutter downspout missing; Gutter downspouts do not direct water at least five feet from the structure.

Several places around the house have noticeable ponding problems, specifically the northwest corner and near the downspouts. This is a potential water intrusion to the foundation that can compromise the foundation. Several areas sloped toward the house and low spots near the structure promote ponding. Recommended to repair by a qualified contractor.

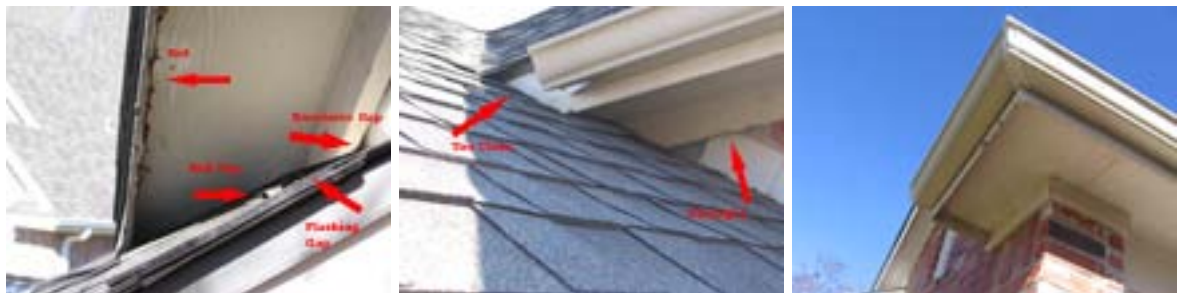
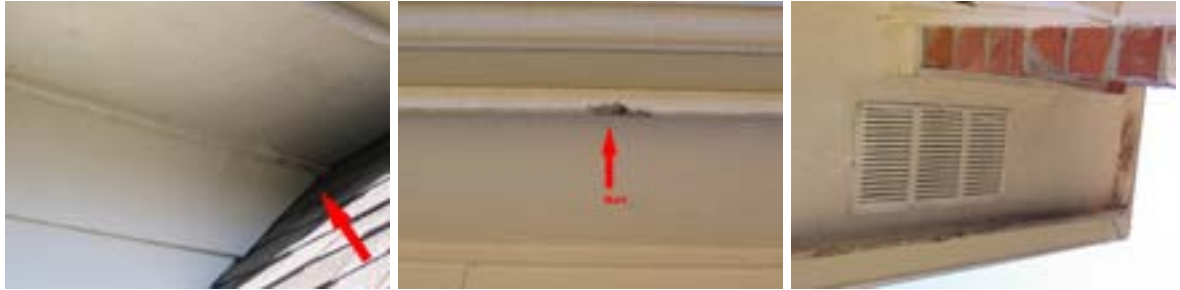
Comments: Most of the fascias around the house were rot or damaged. Some section of the gutter ends and connections has signs of rusting. The gutter at the southeast still retains water. Siding trims are too close to roofing and have signs of deterioration. Normally, they should be 1 to two inches from roofing material. Exposed rusted nails on all the vent flashings. Recommend a qualified licensed roofing contractors to evaluate and repair.

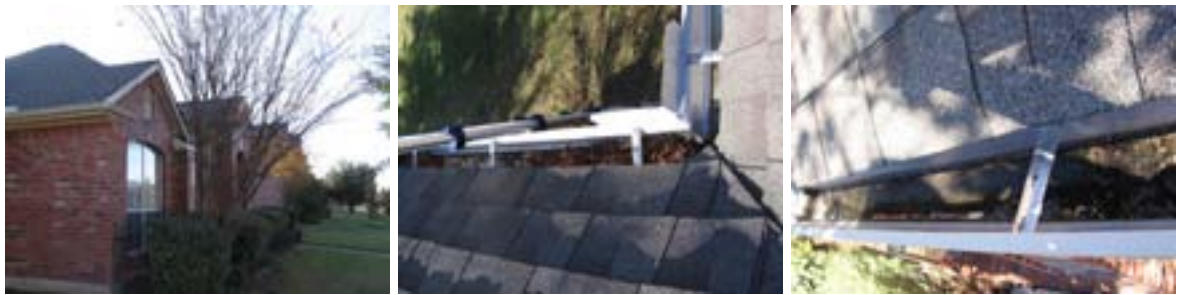
The trees were planted too close to the house. Branches are touching the roof that can cause physical damage to the roofing system. Rodent and insect can potentially cause damage to the house. Recommend trimming these branches.

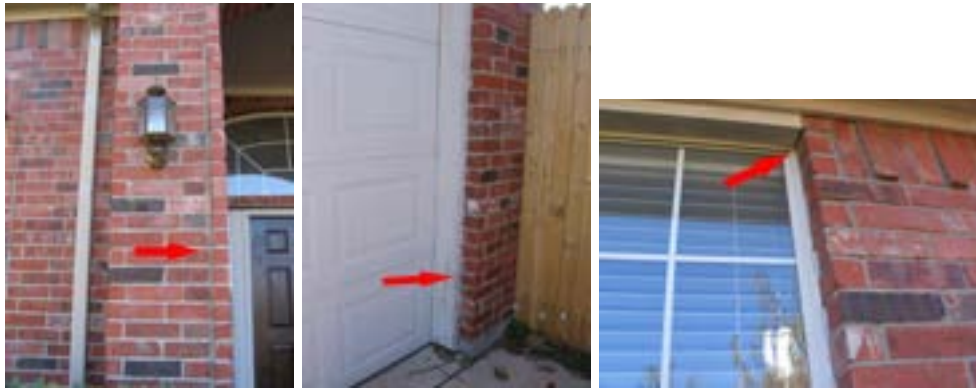
Cracks mortar found at the entrance arc. Recommend repointing by a qualified contractor and monitoring for further problem.

Trim caulk around garage entrances are separated. Reseal.

Exterior openings could lead to structural damage. Sealing prevent moisture penetration around windows, garage trims, trims around the house.

Weep holes need to be clean to allow water to escape.

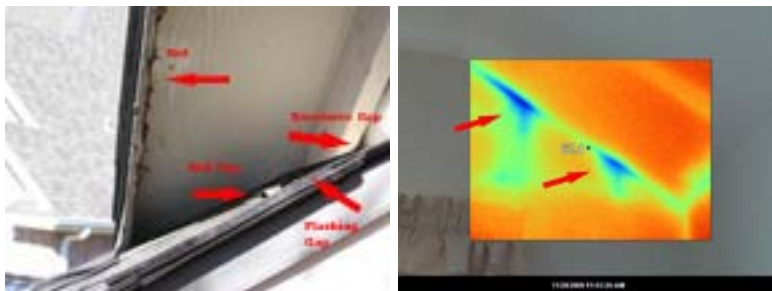
Ceiling cracks found in the bedroom near the office. Thermal image shows sign of possible water intrusion. As the soaking water running down the wall, the thermal image shows it as the fading cold blue along the wall. Coupling with the badly damage fascia within the area of the bedroom, water intrusion is strongly suspect. Recommended to evaluate and repair by a qualified contractor.

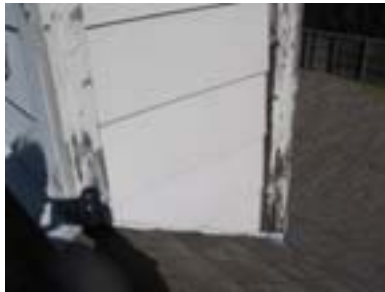
Chimney trims show signs of rot and damage. Recommended repairing by a qualified contractor.

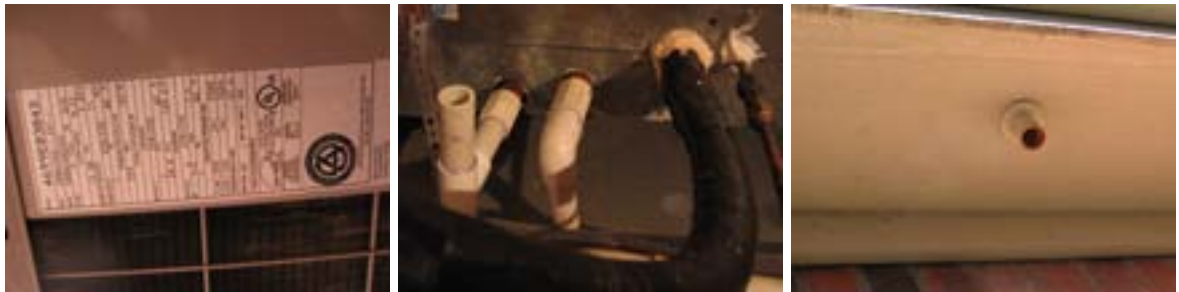
The condenser unit appears to near its service life as evidence by the rusted cover. The primary and secondary outlets appear to be rusted. Rusted stain appears at the secondary outlet. There are sign of previous repair to the suction line. There is no insulation along the primary drain line. This could lead to water dripping as the attic become very hot whereas the drain line is cold. The insulation prevents the line from sweating as it runs from the evaporator coil to the discharge point. Recommended to evaluate and repair/replace by a qualified licensed HVAC contractor.

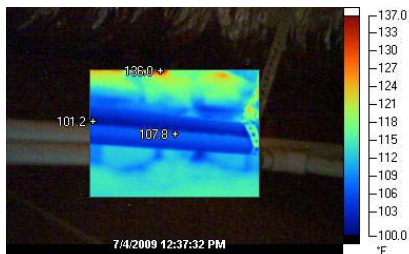
Water dripping from secondary condensate drain line. The thermal image reveals the water in the auxiliary condensate line. Recommend qualified licensed HVAC contractor to evaluate and repair.

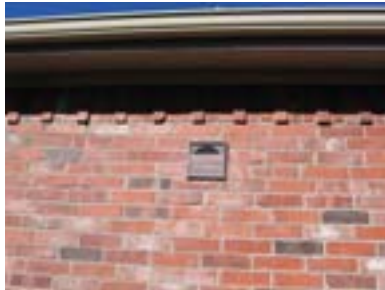
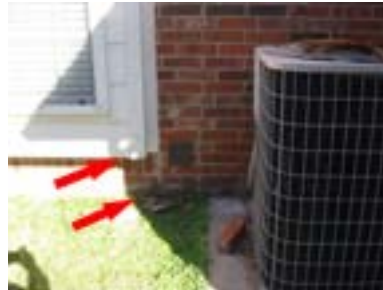
Duct system is not properly supported. Dirty supply registers. Recommended cleaning by a qualified professional.

The exhaust kitchen vent is missing cover plate at the exterior.

Dryer exhaust is too close to the AC condenser that could affect the performance and the efficient of the unit.

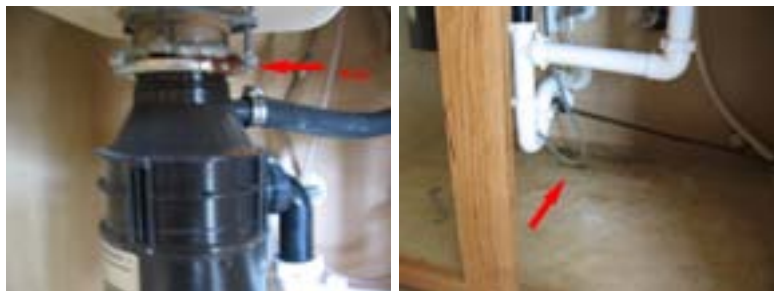
The union of the drainpipe under the sink of the second bathroom was installed with dissimilar material. This is not a normal installation standard. Water leakage found under this bathroom sink. Recommended repairing by a qualified licensed professional.

Grinder retaining rings is rusted. Recommended evaluating and repair by a licensed qualified plumber.

Water stains were seen from the kitchen sink. Both shutoff valves appear to be corroded. Recommended evaluating and repairing by a qualified licensed plumber.

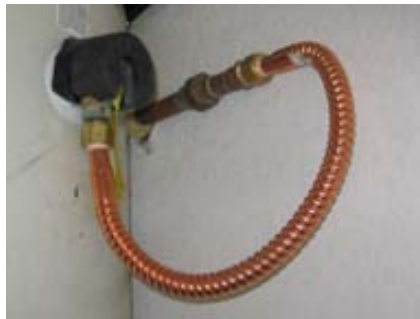
Secondary drainpipe was blocked by the stack of brick and pointed away from the recommended standard. It should terminate to an approved location max 6in. above floor or ground.

Temperature Pressure Relief Valve (TPRV) was connected to a flex pipe and directed to a discharge pipe above it. Testing showed leakage at the connection between the TPRV and the flex tubing. Safety hazard. Recommended evaluate and repair by a qualified contractor.

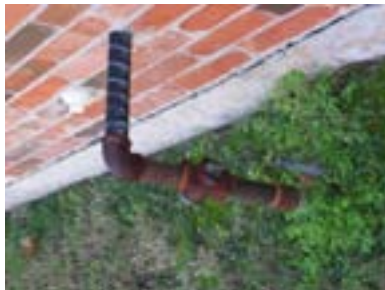
The main gas line was rust and missing bonding. Recommended repairing by a qualified contractor.
